SM300 Tail Light Installation

LAY-TSB-15-001

Model: SM300

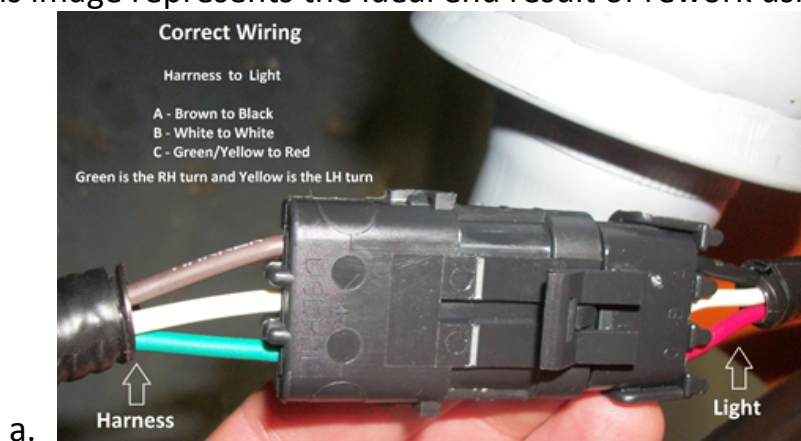
Laymor has determined that there is an issue with the tail / turn signal lights on the 3 wheel sweepers. The tail light turn signal was wired backwards causing the turn signals to be unseen when the tail lights are on.

1. Find and disconnect tail light interconnects near tail light.
2. You will see that on the mail connector, attached to the tail light, the following wire colors in each connector 'position'
 - a. Red
 - b. White
 - c. Black
3. The objective is to swap the wire/signals from position A to position C and the wire/signals from pin C to pin A
4. This can be done in one of two ways detailed below
5. The end goal is to have the connector positions populated, with the wire/signals coming from the tail light, in the following order
 - a. Black
 - b. White
 - c. Red
6. This image represents the ideal end result of rework using repair option 1
