## **SM300 Tail Light Installation**

### **LAY-TSB-15-001**

**Model:** SM300

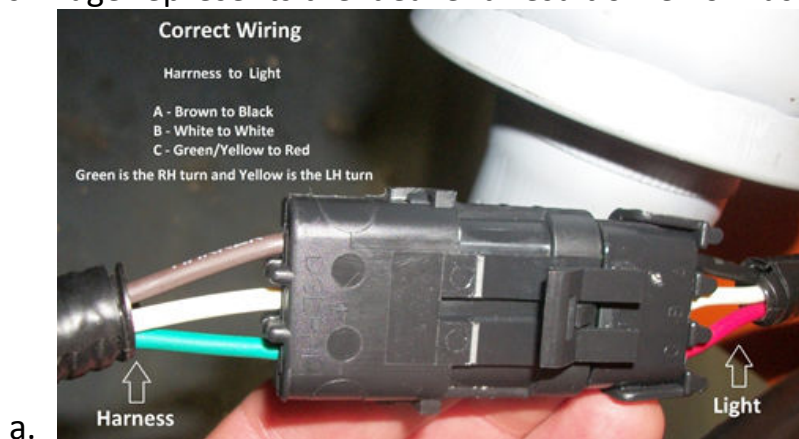
Laymor has determined that there is an issue with the tail / turn signal lights on the 3 wheel sweepers. The tail light turn signal was wired backwards causing the turn signals to be unseen when the tail lights are on.

1. Find and disconnect tail light interconnects near tail light.
2. You will see that on the mail connector, attached to the tail light, the following wire colors in each connector 'position'
  - a. Red
  - b. White
  - c. Black
3. The objective is to swap the wire/signals from position A to position C and the wire/signals from pin C to pin A
4. This can be done in one of two ways detailed below
5. The end goal is to have the connector positions populated, with the wire/signals coming from the tail light, in the following order
  - a. Black
  - b. White
  - c. Red
6. This image represents the ideal end result of rework using repair option 1
