SM300 ZTR Jumper TSB

LAY-TSB-15-002

Model: SM300

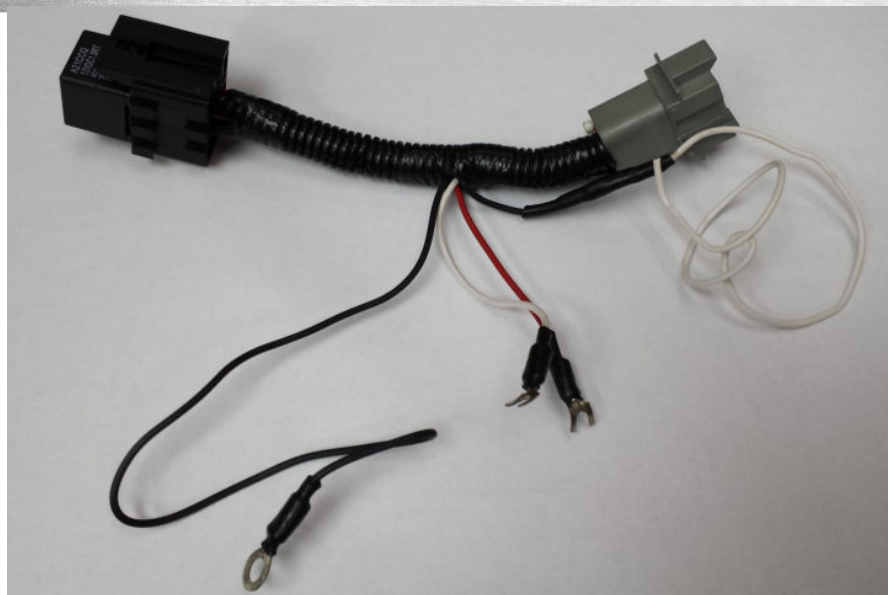
1. Find ZTR jumper/relay under the right side of the dash panel.
 - a. You can follow the cable leading from the ZTR module, mounted to the right side of the dash support column, to the ZTR jumper.
2. Carefully note where the jumper connects into the SM300 electrical system.
 - a. At the end of this process the jumper will need to be re-installed in the same manner.
3. Disconnect the ZTR jumper, pictured below, from rest of unit's electrical system.
 - a. Cut the white wire in a way which is advantages for re-splicing during reconnection.

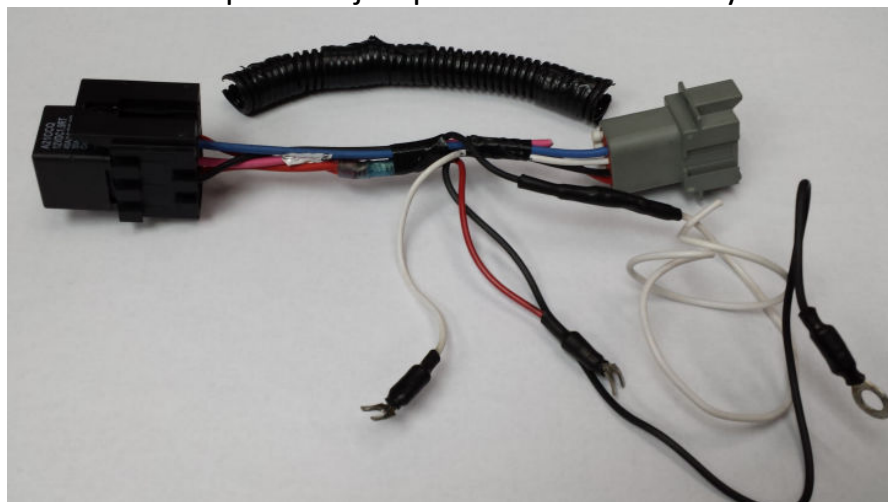
4. Remove loom and tape from jumper. Disconnect relay.

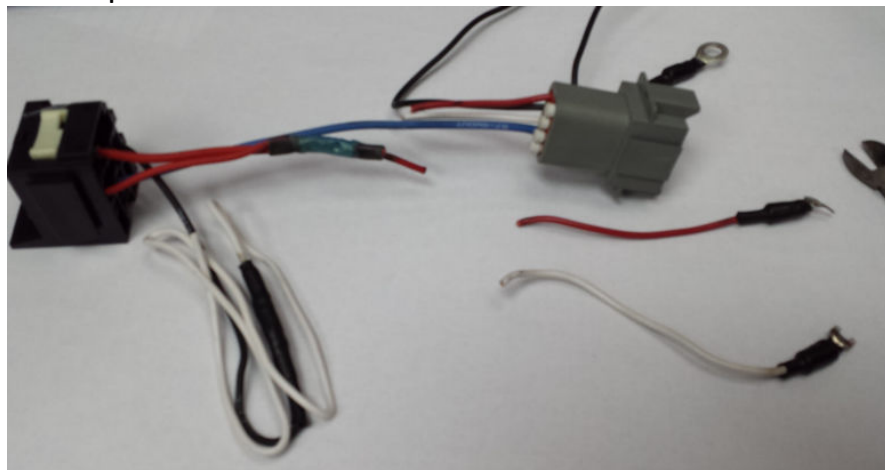
- b.
5. Cut the red and white wires leading from the grey connector as described and shown below.
 - a. Cut the red wire approximately 1 inch from the splice already present.
 - b. Cut the white wire at approximately the same location.
 6. Cut the red wire with ring terminal coming from the already present splice flush to the splice.

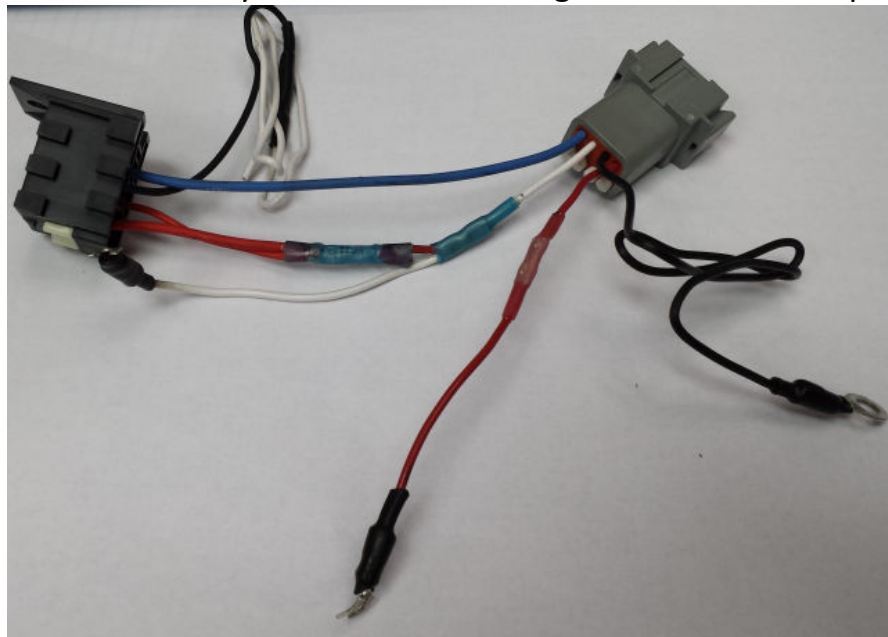
- b. Red and white wires extending from the grey connector.
 - c. Red wire extending from the already present splice.
8. Splice the white wire (coming from the gray connector), the white wire (with the terminal), and the red wire (extending from the already present splice) together. Splice the red wire (coming from the gray connector) to the red wire (with the terminal).
- a. Ensure that each wire is securely spliced and that the splice is environmentally sealed either through heat shrink or tape.

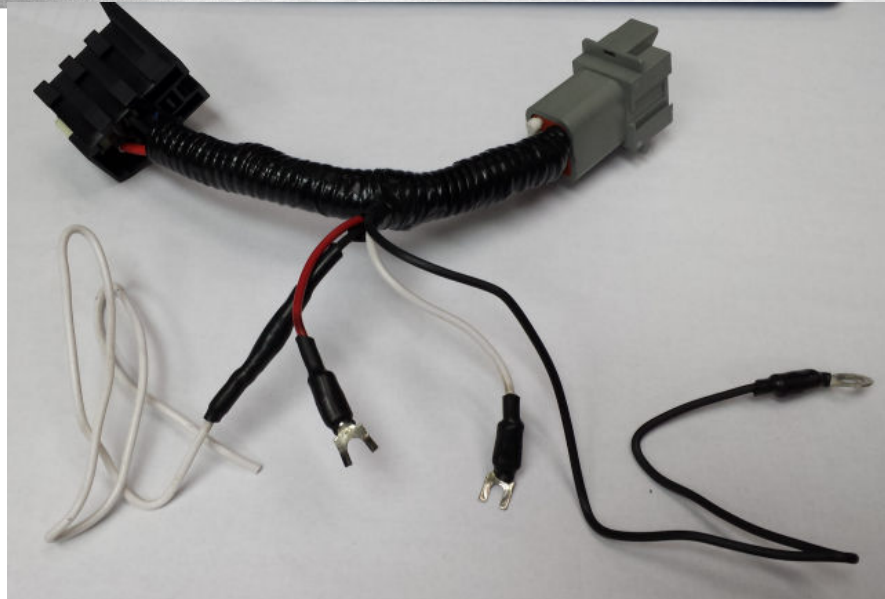
- b.
9. Tape the wires together into a bundle and re-loom the jumper.
